**POTOSI LAKE DAM  
WASHINGTON COUNTY, MISSOURI  
MO 30477**

**PHASE 1 INSPECTION REPORT  
NATIONAL DAM SAFETY INSPECTION**

**SEPTEMBER 1980**

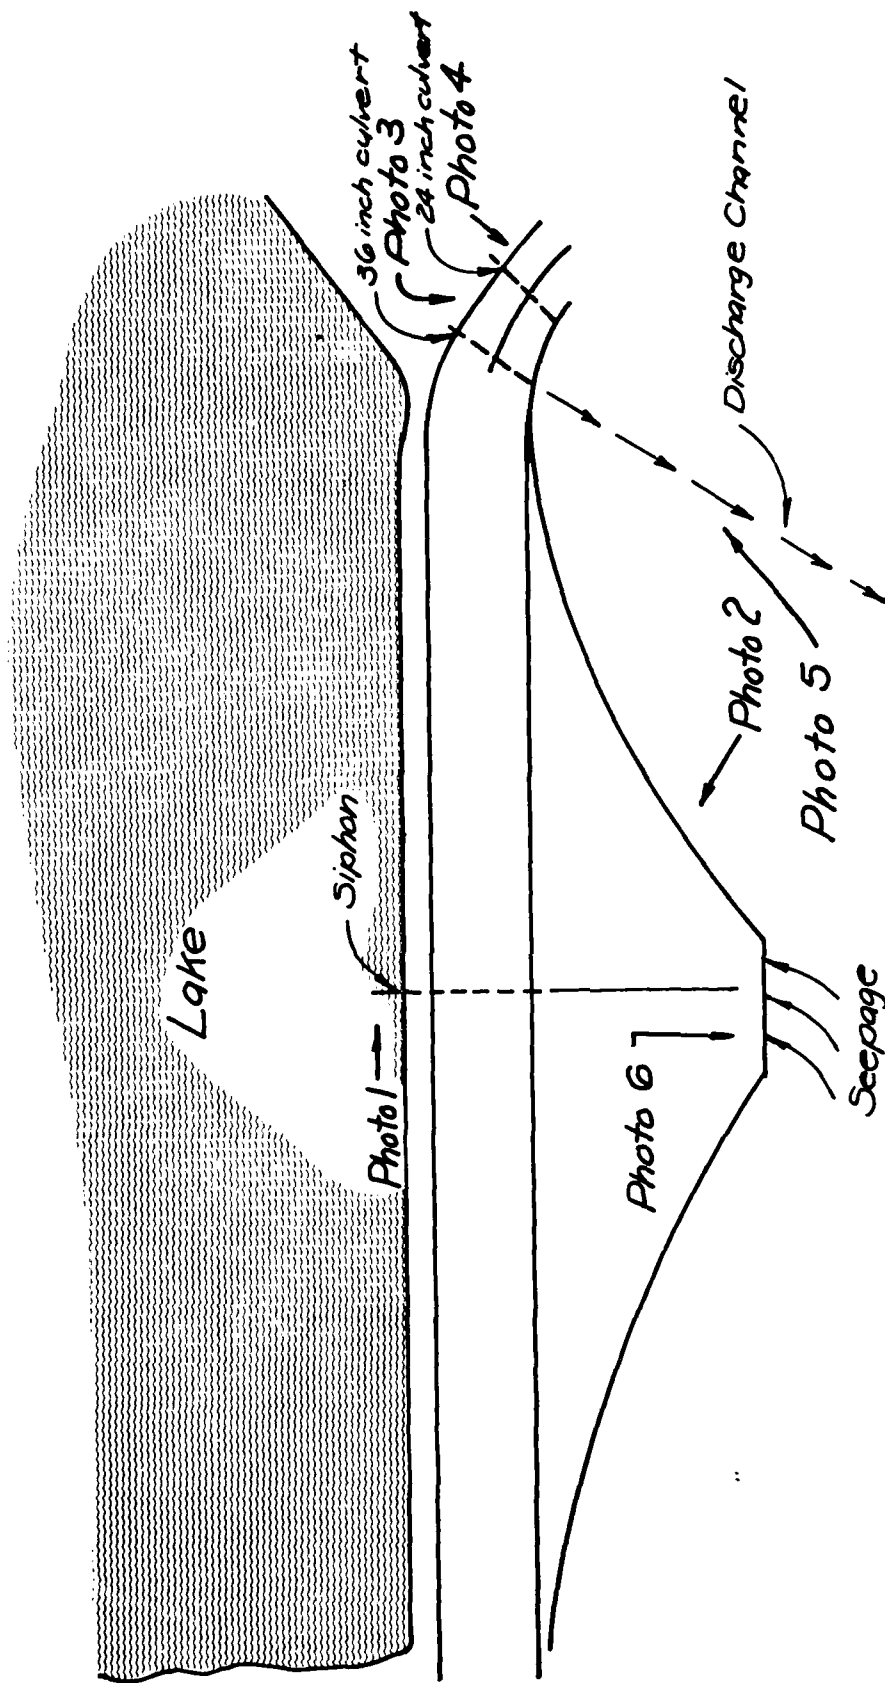
Fig. A-1

Clear seepage was noted along about a 100-ft length of the dam toe in the area of the maximum section. The rate of seepage was estimated to be 30 to 50 gal/min. Seepage was not concentrated at any single point, but rather in a band at the toe of the dam (see Fig A1; Appendix A).

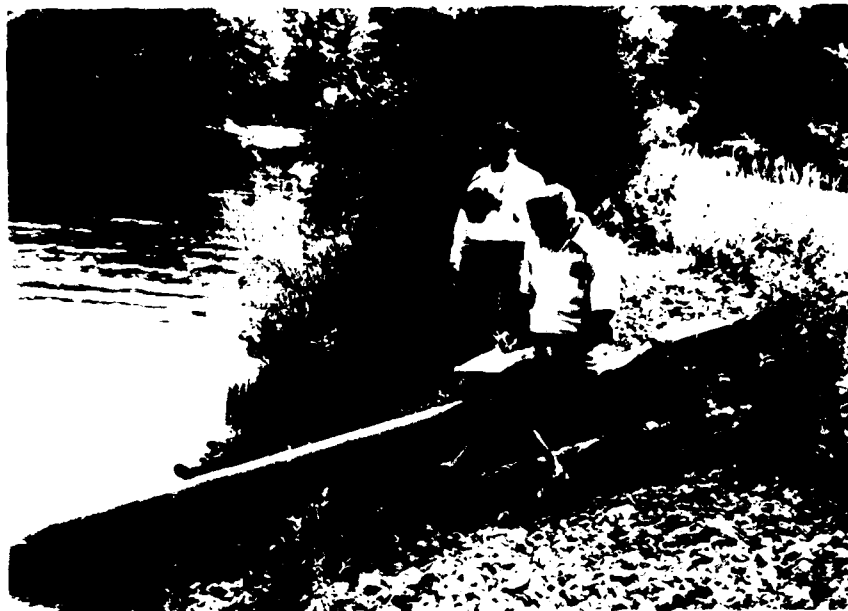
3. Siphon. The siphon consists of a 12-in. dia steel pipe with an air vent at the throat (Photo 1; Appendix A). The throat crest is above the dam crest elevation. Therefore, the siphon must be started manually as it will not flow until the lake elevation reaches a level above the vent. The outlet is at the dam toe. The lower leg passes under the road and rests on the downstream slope of the dam. Details of the inlet are not available. The exposed portions of the siphon appeared to be in good condition.

1. Upstream dam slope showing siphon inlet and gravel wave protection.
